# CITY OF LAUREL

## Riverside Park Master Plan

**February 2018**

## **RIVERSIDE PARK MASTER PLAN**

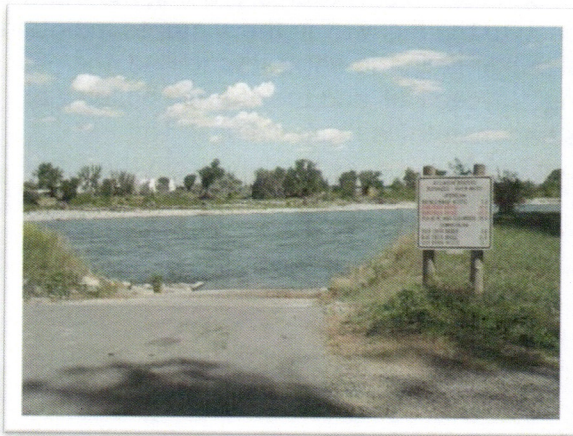
Boat Ramp

The existing boat ramp was reconstructed in 2014 in conjunction with the bank stabilization project that addressed the impacts of the 2011 flood. The ramp consists of a concrete apron that extends into the river and an asphalt pavement section located at the top of the ramp. Both surfaces are in good condition, but should receive annual maintenance by Montana Department of Fish, Wildlife and Parks (FWP) on the asphalt and adjacent riprap to remain functional.

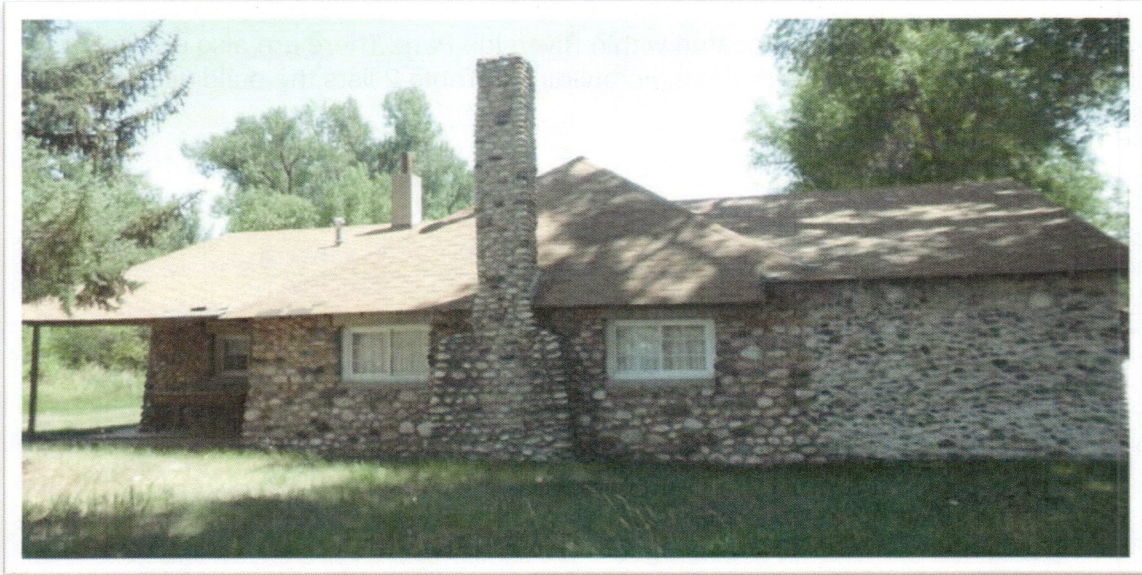
American Legion Building

This building was previously used as the headquarters of the American Legion Laurel Post 123. Upon the departure of the Legion from the building in 2011, the structure has remained vacant. The building is showing rot on rafters and roof sheeting. Also, water has penetrated the roof and has caused the ceiling in the bathroom to collapse. Subsequently the interior of the building is now exposed to the elements. This building is in need of substantial repair and deferred maintenance if it is going to remain a viable structure.

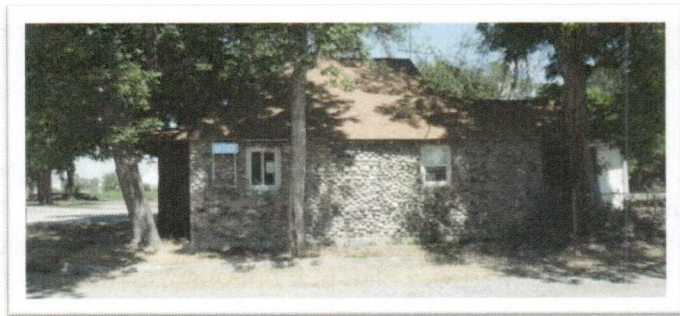
Caretaker Building

Prior to the 2011 flood, this building provided housing for the individuals who helped manage and oversee the use of the campground and other facilities in the Park. The structure is located in the central part of the Park. During the flood, the structure was damaged to such an extent that the City has determined that it is not worth the cost of rehabilitation. Therefore, it will eventually be demolished. Evidence suggests that there may be an old heating oil tank buried in the ground underneath the building. This would need to be removed when the building is demolished.

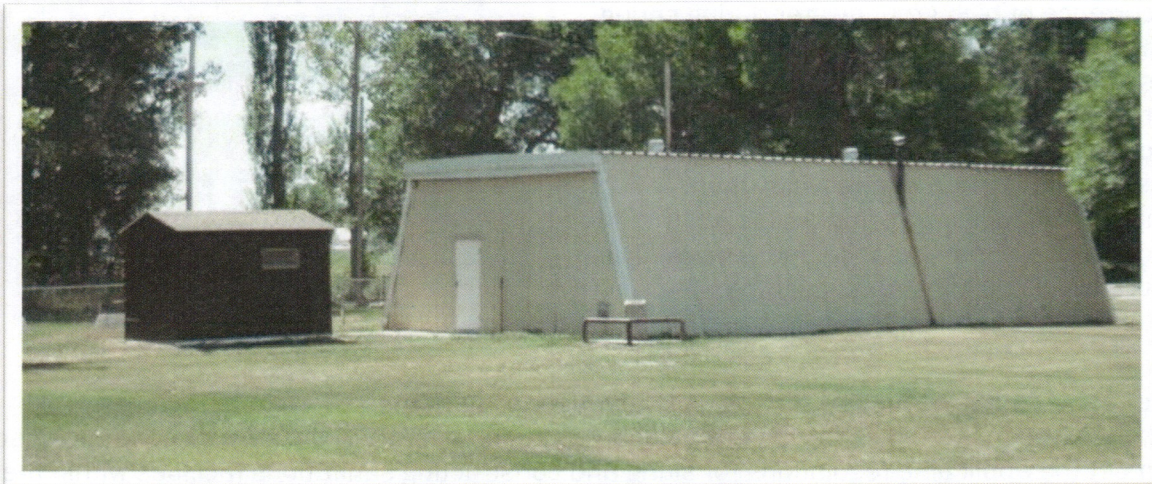
The Horseshoe Club Building is a metal sided and metal roofed building that is owned by the Laurel Horseshoe Club. The Club leases the land upon which the building sits from the City. The building houses indoor horseshoe courts, which are used in the winter for competition.

The Club building is located in the south central part of the Park adjacent to the outdoor horseshoe pits. The building is in relatively good condition and appears to currently need minimal maintenance. While the Club building is for the exclusive use of Club members, the outdoor horseshoe pits are owned by the City and open to the public. The Club pays for electrical service

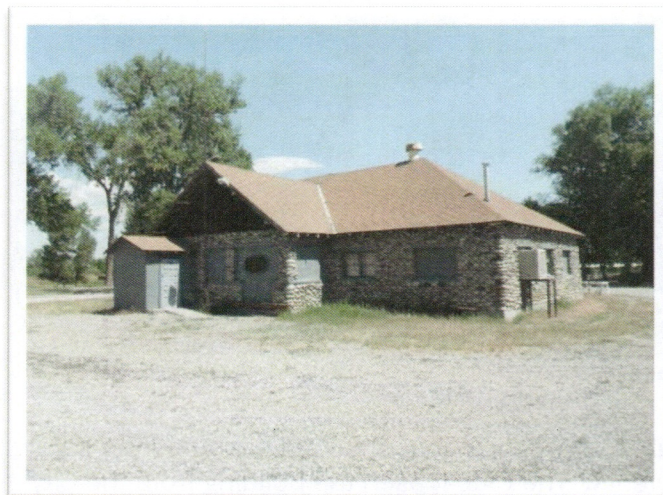
Jaycee Hall was one of the few buildings in the Park that experienced minimal damage from the 2011 flood. In fact, during the flood, staff from the City graded a berm around the building to direct flood waters around the structure. The building is leased to the Laurel Jaycees and is used as a meeting place for the organization and the building is rented out by the Jaycee's for events such as weddings, banquets, reunions, etc. The building has a large meeting room, kitchen facilities and restrooms. The

structure is in relatively good condition and is in need of typical maintenance, such as the replacement of the roof which dates from 1991. There is a small storage building used by the Jaycees that is located northeast of the main building. This building appears to be in good condition.

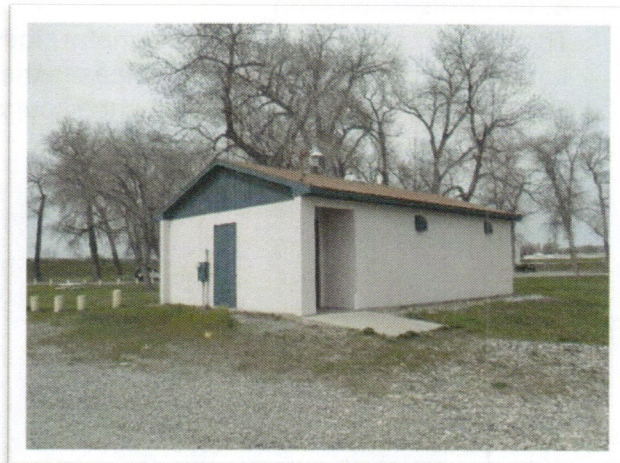
Existing Public Restroom Building

The public restroom building is a concrete block building with a shingle roof located in the west central area of the Park. This facility is not currently functional. During the occurrence of high groundwater during spring runoff, the restrooms in the building will not flush and water will not go down toilets, due to the flooding of the drain field and tanks. In addition, the plumbing for the building is located within the concrete walls, thus making it difficult, if not impossible, to undertake any maintenance and repairs. The future of this building remains to be determined.

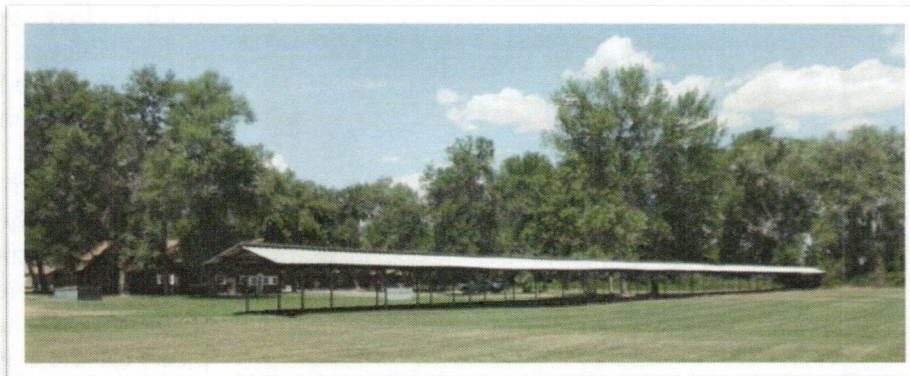
Historic Rifle Range

been used as a meeting place for the Club, to conduct indoor shooting, teach hunter safety and to host other shooting and archery events. The Club leased the building from the City and this lease expired in 2003. Because of issues related to the current condition of the building, the City Council decided not to renew the lease. The building has a number of structural and operational issues. The structural issues include the collapse of the bathroom ceiling resulting in significant water damage and mold. Also the roof has reached its life expectancy. From an operational standpoint, the interior of the building contains

elevated levels of lead caused by the discharge of firearms without adequate ventilation and cleaning. These elevated lead levels present a threat to public health and safety. In order to reduce the City's exposure to any liability due to the elevated lead levels, the City Council closed the building to public access and use.

The building is in need of significant repairs, including to the roof, the removal of the bathrooms and the remediation of the lead in the building. In addition, the future of indoor shooting in the building would require a very significant investment in the reconstruction of the building and installation of an air filtration system and other improvements to meet state and federal health and safety standards.

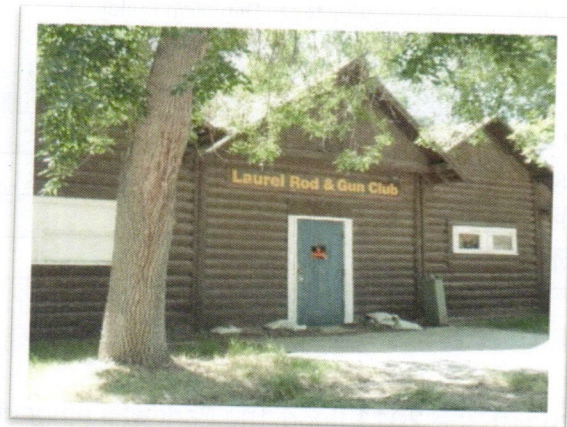
**Laurel Rod & Gun Club Building**

Since 1929, this building had been the headquarters and meeting facility for the Laurel Rod and Gun Club. The building was damaged during the 2011 flood and the timbers comprising the lower walls on the building are showing signs of rot. Testing paid for by the Rod and Gun Club suggests that there is minimal mold and asbestos contamination minimal. The building has not been used since the flood. The lease for the building expired in 2008.

The Laurel Rod and Gun Club is interested in repairing this building so the Club can once again use the structure for Club functions. Knowing that the City does not have the resources to undertake this project, the Club has indicated that it is willing to provide the resources, time and money to complete the project. To that end, the Club has obtained an estimate for the repair and revitalization of the building, which is approximately \$45,000.

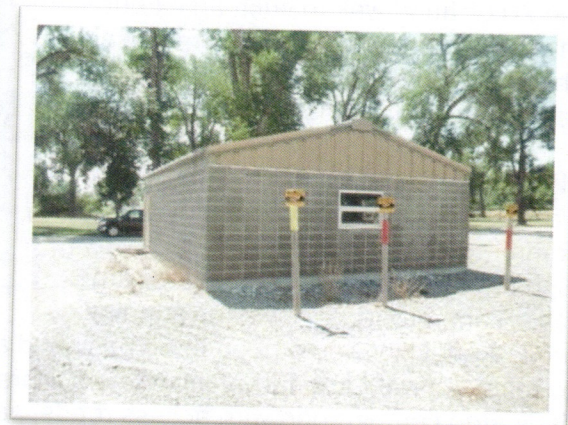
**Williston Basin Pipeline Building**

The pipeline building, which is located in the middle of the main entrance road, is owned and maintained by Williston Basin Incorporated (WBI). The maintenance building is of concrete block construction with a metal roof and is in good condition.

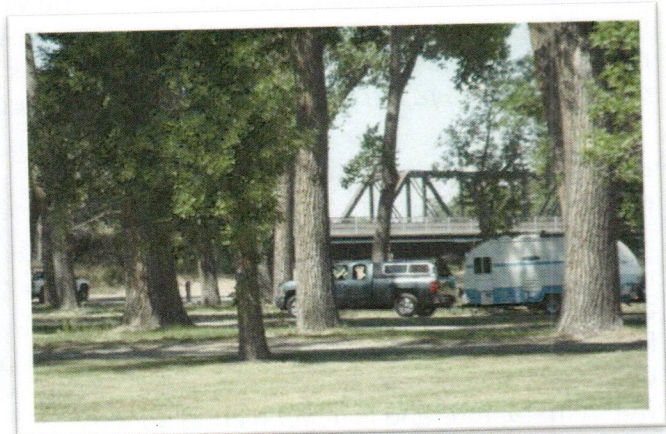
Former Campground Area

Prior to the 2011 flood, the Park was a popular location for people to camp, particularly travelers. At one time the Park provided public restrooms and water hookups for campers. There was also an onsite caretaker who lived in the caretaker’s house and helped provide management of the camping and other Park facilities. Camping was located mainly in the northwest corner of the Park between the main access road and the river. The damage caused by the 2011 flood was to such an extent that the restroom facilities were closed. Thus, without sanitation facilities, the campground was closed.

The reestablishment of a campground was identified by the project advisory committee and City residents as a very high priority. In order to compete with other campgrounds in the surrounding area, the facility would need to be designed and constructed to ensure that it could be used by full sized recreational vehicles and trailers. This would include the development of a dedicated campground with access roads, parking areas for RV’s, restroom facilities, water hookups and garbage disposal. A new campground should also include facilities for tent camping.

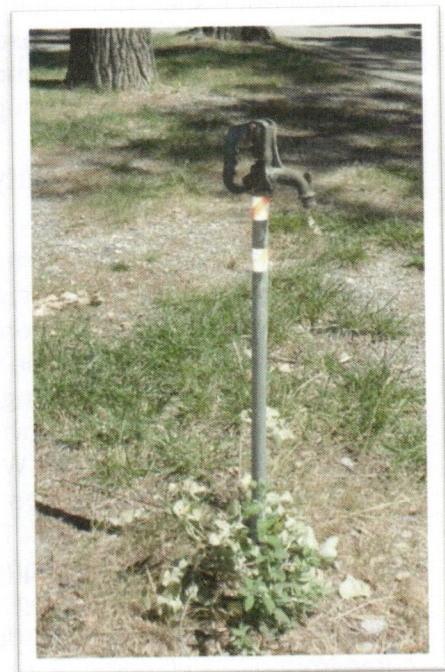
Frostless Hydrant in Park

The water service has only been in seasonal use since 2010, due to the failure of heat tape that kept the line on the bridge from freezing. The failure of the tape caused the line to freeze and break. The pipe was eventually replaced with the 3" HDPE, but the break(s) in the heat

tape could not be isolated and repaired. The City completed a cost benefit analysis on replacing the heat tape vs letting the water run continuously during the winter at Jaycee Hall. The City found that letting the water slowly run on the building's kitchen and bathroom fixtures to prevent freezing was less expensive than installing and powering new heat tape. The frostless water hydrants located at the old RV camping spots are in poor condition. In fact, many have been run into by vehicles and are now bent. It is unknown if they still function. These hydrants would need to be assessed to determine if they still properly function. It is likely that most would need to be replaced if they were to be put back into service.

The constraints of the existing water system are three-fold. First the underground 4" cast iron line within the Park does not have adequate soil coverage over the pipe to prevent potential freezing in the winter. Second, the available water flow volumes to the Park are inadequate. The current flow rate, estimated by staff at the City Public Works Department, is between 50-75 gallons per minute, which will not allow for the operation of a fire truck. Adequate fire flows would need to be closer to 1,000 gpm minimum. The third issue is the long-term viability of using the water line suspended along the bridge. Potential options for providing drinking water to the Park may include replacing the line across the bridge and/or installing onsite wells. Such wells may not be an option for providing fire protection water flows unless they are very large and capable of producing a high volume of water.

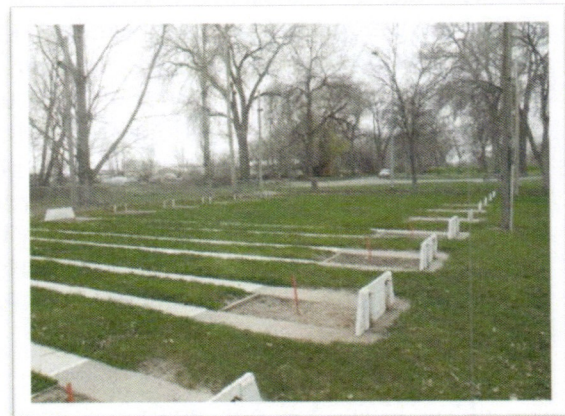
**Horseshoe Pits**

The Horseshoe Club facility in the Park consists of a tournament quality horseshoe course with 15 pits and a clubhouse. According to the documents held at the City, the pits were constructed in the 1970's using Land and Water Conservation Funds provided by the Montana Department of Fish, Wildlife and Parks. The clubhouse is owned by the Club, but the land is leased to the Club. The facility is in good condition and should require basic maintenance to ensure its long-term use. The facility does not see the use it did in the previous decades, but incorporating it into a new campground design could help to revitalize it.

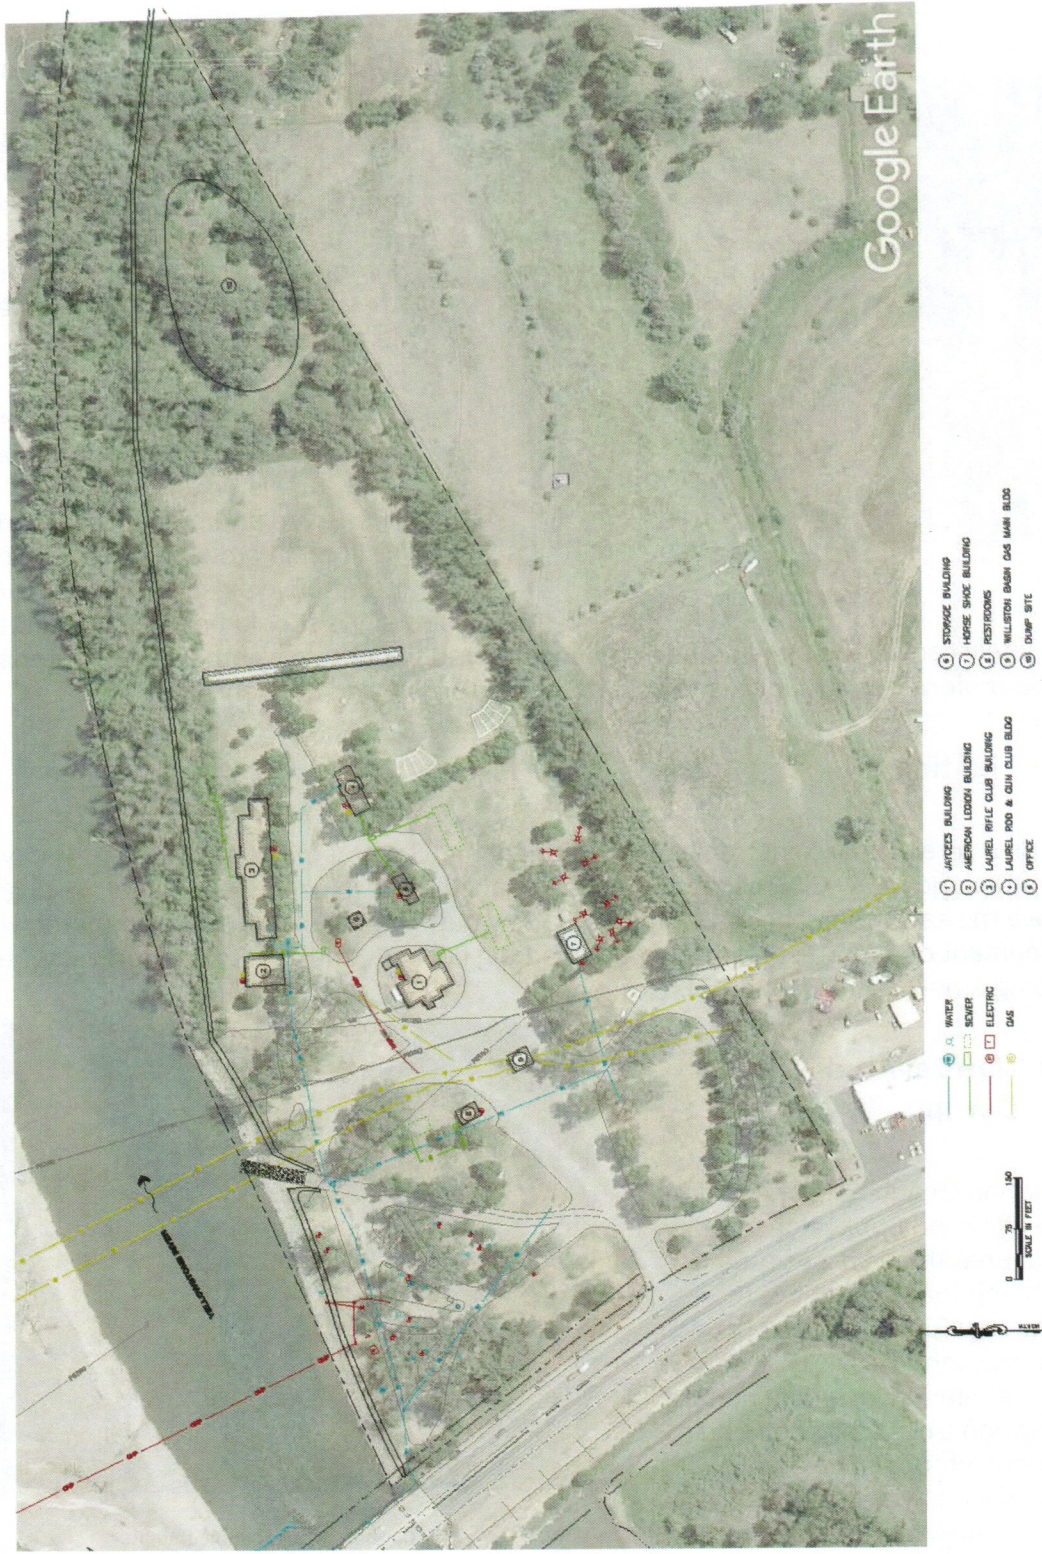
Figure 2 - Existing Conditions

At one time all buildings had water and sewer services, except the storage building which has no services and the Horseshoe Club building which only has water service. The general location of the septic systems and drain fields that serve the buildings are shown on the Figure 2. The exact locations of several septic systems is unknown. The condition of the water and sewer systems is discussed further in Section 4.5 and 4.18.

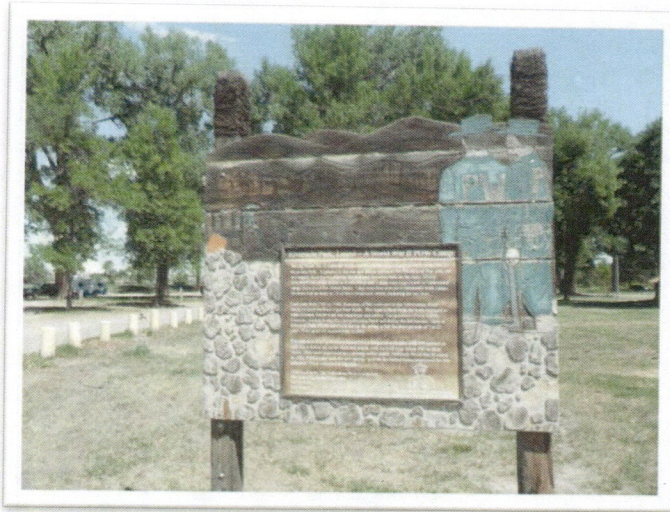
Existing Interpretive Sign

The Park has a rich history and there are many stories to tell. These range from the homestead era through the Works Progress Administration Camp and the World War II prisoner of war camp. While there are several interpretive signs located in the Park, they have become weathered and are in need of replacement.

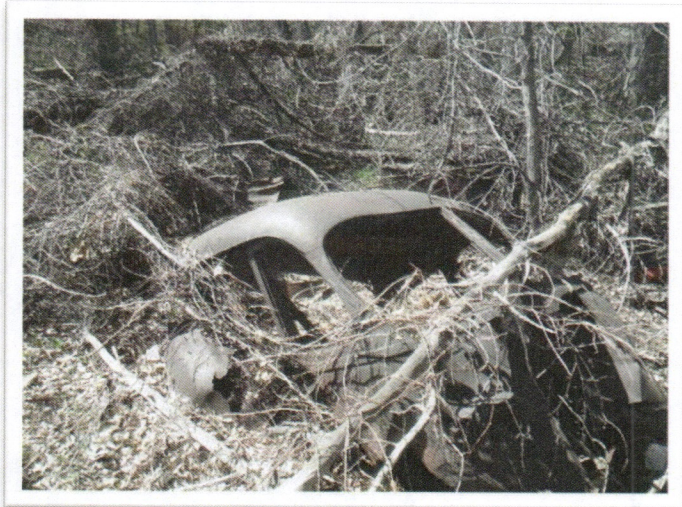
Car Body in the Historic Dump

Located north and east of the old rifle range is an undeveloped natural area that is associated with the riparian corridor of the Yellowstone River and the historic garbage dump. This is an area of dense vegetation including mature cottonwood trees, dogwood and snowberry shrubs. The area is typically used by a variety of bird species, small mammals and whitetail deer. The area is

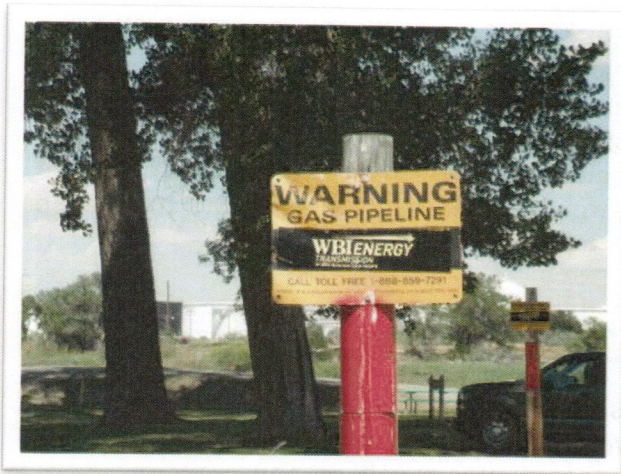
Pipeline Sign in the Park

There are a number of underground pipelines within or near the Park. The Exxon-Mobil Silvertip crude oil pipeline lies 750 feet downstream of the Highway 212 bridge. Two other pipelines, one for crude oil and another for natural gas are operated by Williston Basin Interstate Pipeline and they cross beneath the river and run through the Park. Williston Basin also has a pipeline maintenance station located in the western portion of the Park. This building is located in the middle of the main access road. Williston Basin Incorporated has an easement for the operation and maintenance of these pipelines.

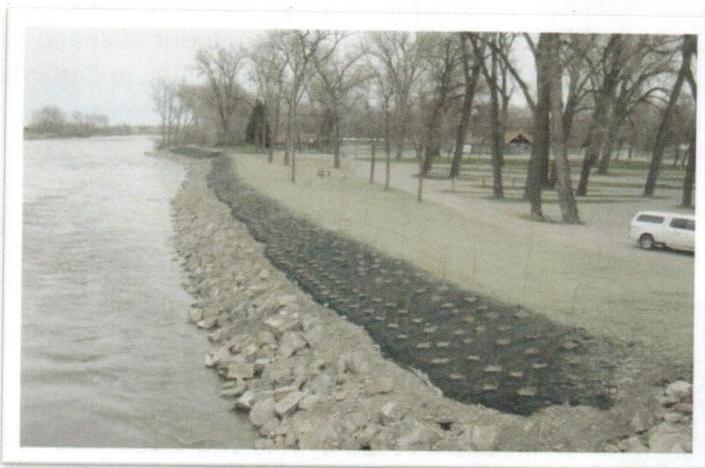
New Levee

The flooding and erosion that occurred in 2011 left the south bank of the Yellowstone River along much of the Park boundary at a near-vertical slope. To address this situation, the City of Laurel secured funding from the Federal Emergency Management Agency (FEMA) to construct improvements that would not only help to protect the City's drinking water intake structure in the river, but also protect the Park. These improvements included reconstruction and stabilization of

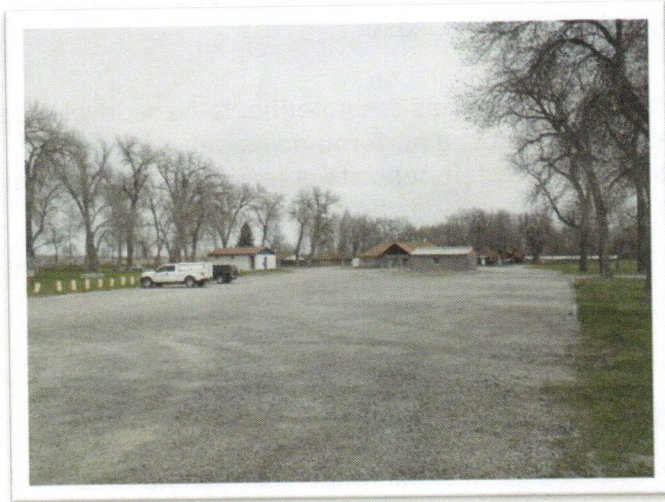
Existing Road Surface in the Park

The Park's internal road network is poorly defined in many places with the driving lanes and parking areas overlapping. In addition, the driving lanes for the main entrance road are extremely wide, particularly from the highway up to Jaycee Hall. Also, random curbing can be found throughout the Park and it is not known what purpose they previously served.

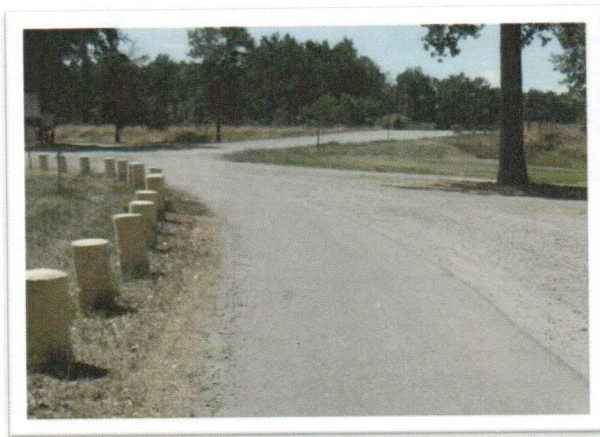
Existing Asphalt Trail

There is currently no designated trail network within the Park. There is a short section of asphalt trail that goes from the boat ramp and then southwestward to the main access road by Highway 212. There is an unmaintained trail along the top of the historic levee that goes from approximately the boat ramp into the wooded area around the historic dump. This unmaintained trail could serve as the basis of a defined walking trail, but would need significant work. Any new trail network should be designed to provide access to the entire Park property including the natural area in the east of the property.

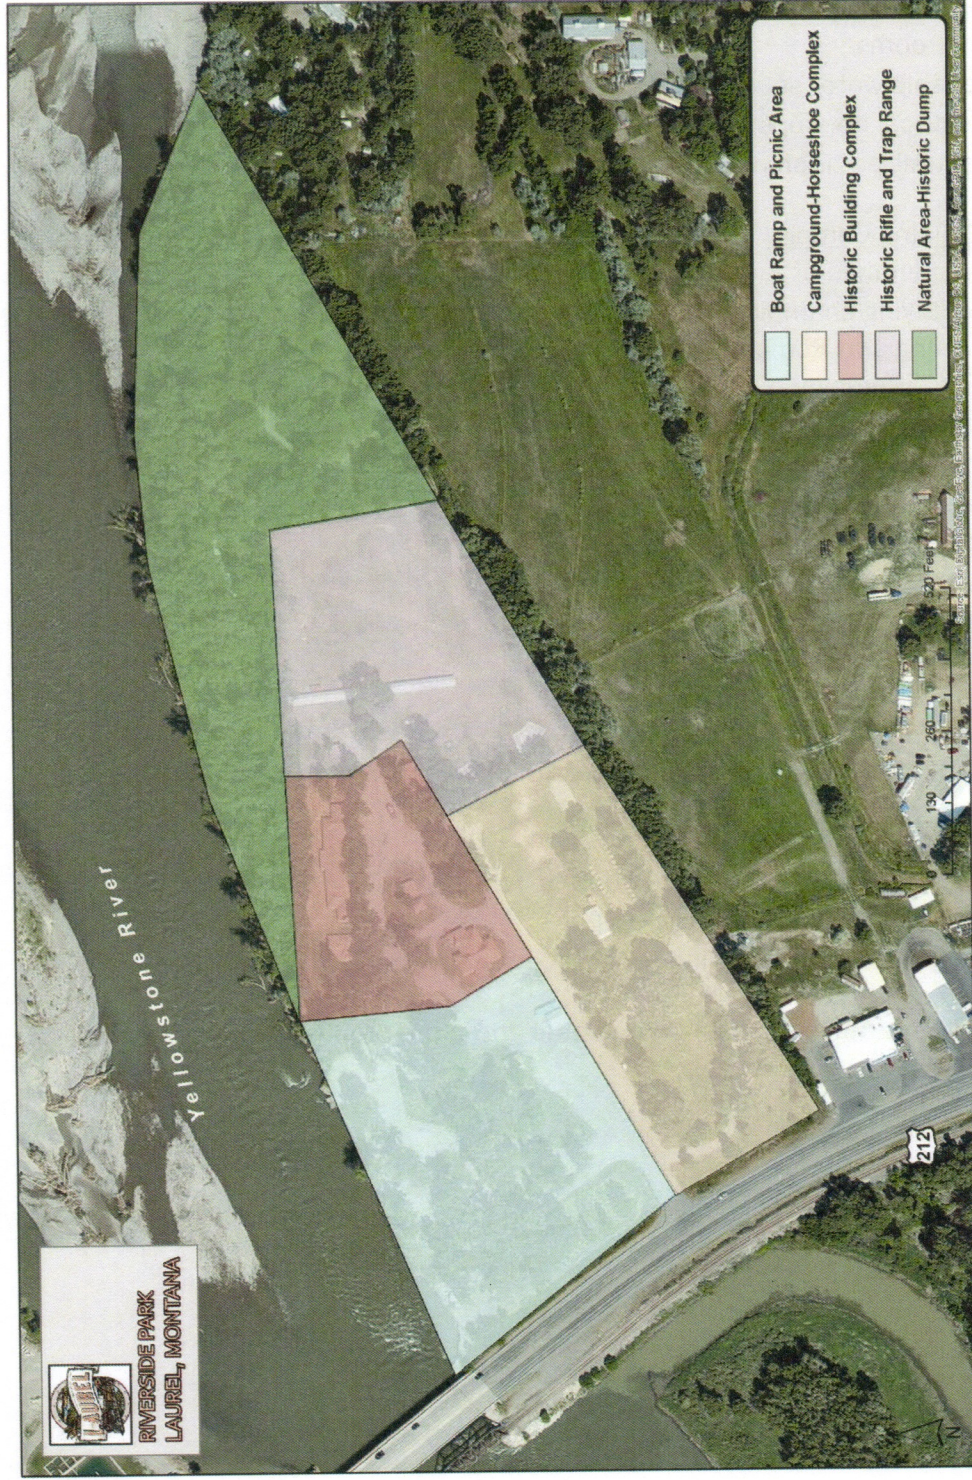
Figure 3 - Park Design Areas

Figure 3 shows the approximate locations of each area.

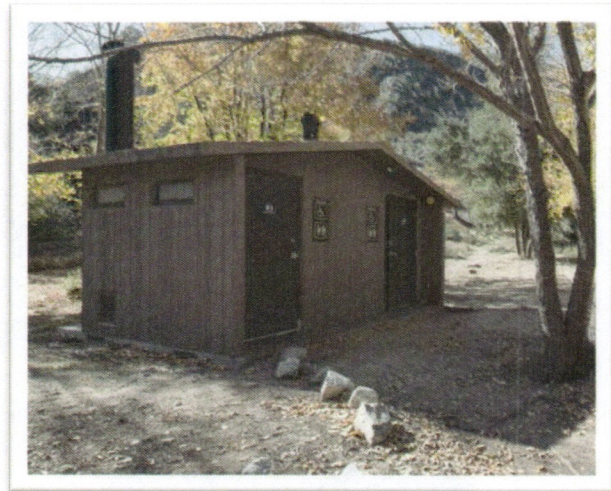
Vault Toilet

Due to the Park's location within the 100-year floodplain of the Yellowstone River, any new public restrooms would likely need to be of a vault toilet design. Such structures would need to meet the applicable regulations for siting and constructing sanitation facilities within the 100-year floodplain, which involves elevating the top of the storage vault 2-feet above the base flood elevation.

If the existing public restroom building cannot be rehabilitated, it will be replaced with a vault toilet, ideally in the same general location. In addition, public restrooms should be installed in appropriate locations to serve the future campground and other development. Due to the fact that the Park is in the floodplain, any new vault toilets would need to be elevated above the base flood elevation.

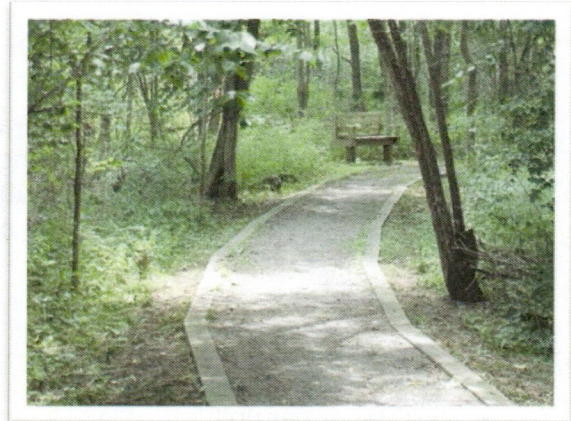
Example Trail

While not necessarily a high priority, the development of a trail system throughout the Park is a logical recreational facility that would provide recreation and safe pedestrian/bicycle access around the Park. A trail in the east end of the Park would only be possible with the end of trap shooting. A trail system could also provide access to the proposed fishing access downstream of the boat ramp. Any trail system would likely be constructed of gravel.

- 5,500 linear feet of a gravel trail system: \$31,000

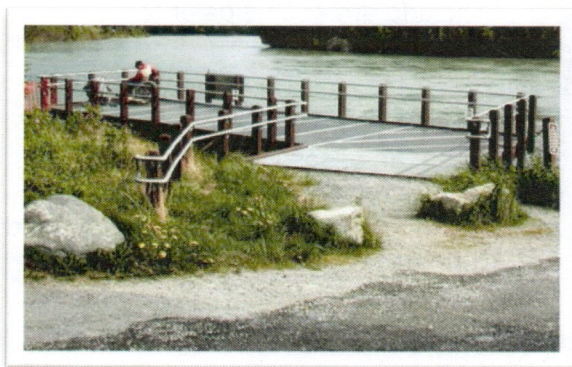
Example ADA Fishing Access

While the existing Montana FWP boat ramp provides good access to the Yellowstone River for boaters, pedestrian and wade fishing access is very limited in the Park. This is primarily due to the steep bank along the rehabilitated levee upstream of the boat ramp and the density of vegetation along the river bank downstream of the ramp. In order to improve access to the river for pedestrians and wading anglers, the plan proposes a fishing access downstream of the ramp for foot travel and to provide access for people with disabilities, ADA
